Extraneous Objects in Gray Cotton Goods. A Source of Trouble for Weaver and Finisher Alike

By C. MARTINI.

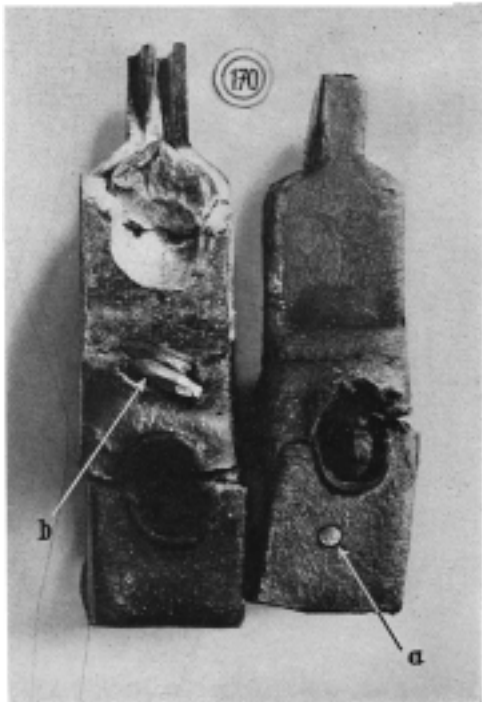
Fig. 1

Figure No. 1 shows both ends of the narrow sides of a raw-hide loom picker. The small tack "a" is the same as that shown in the cloth of Figure No. 2. Both substances were found thoroughly imbedded in

a piece of warp sateen. The heavy rivet in the picker, marked "b" in Figure No. 1, which holds together the two sides of the picker, was found in a much distorted and broken condition in a cloth shown in Figure No. 3. Small nails have been found lately in increasing numbers in goods. This is illustrated by Figure No. 4. Adjacent to the broken nail can be seen the hole which it caused.

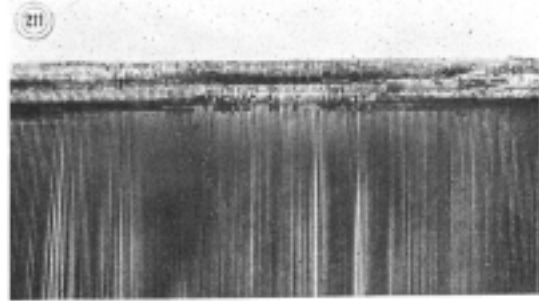
Fig. 5

In a great many instances, extraneous matter comes from worn out reeds. These reeds, through long usage or careless handling, split and, due to their weight, pieces fall into the fell of the cloth and are woven in. (See Figure No. 5.) Figures No. 6 and No. 7 show such particles placed on white paper, in order to show them up better. Figure No. 8 shows six pieces of wire woven into a piece of cotton damask. These were caught by an unusually alert workman. Had any of them been allowed to pass on, they would have caused a great loss to the finisher.

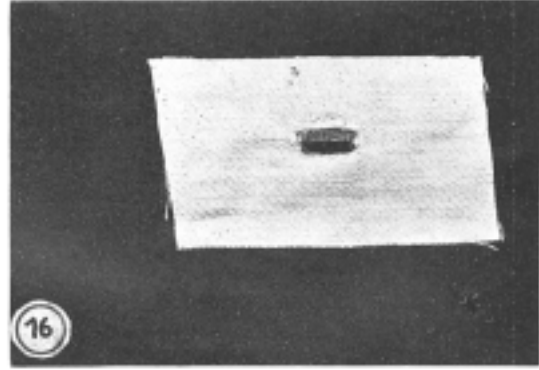
Fig. 10

In Figure No. 10, a piece of iron from an automatic loom is shown.

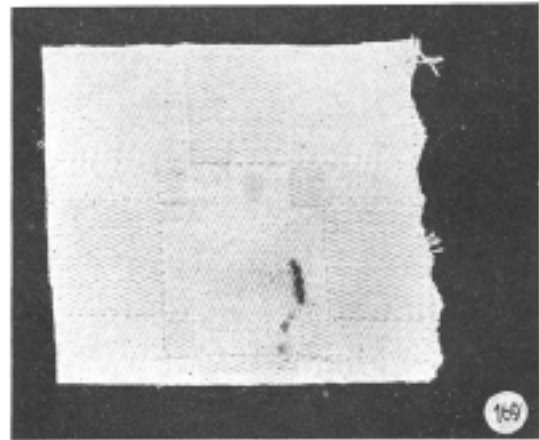
Fig. 11

In Figure No. 11 a piece of iron or steel wire is shown, the origin of which could not be traced or explained by the superintendent in charge of the weaving mill, in spite of the fact that two analogous cases were observed in a short time.

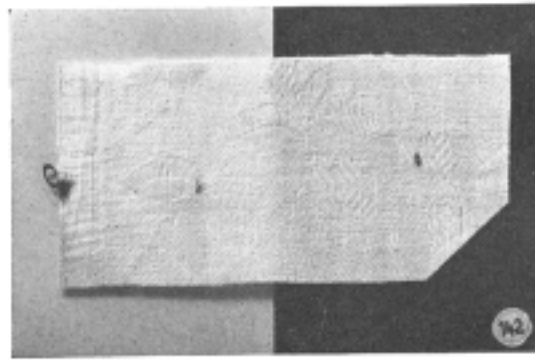
Fig. 9

When mail eyes in a Jacquard harness break or loosen, often they are woven in the cloth. This causes a particularly hazardous condition if allowed to go into certain finishing operation. (See Figure No. 9.)

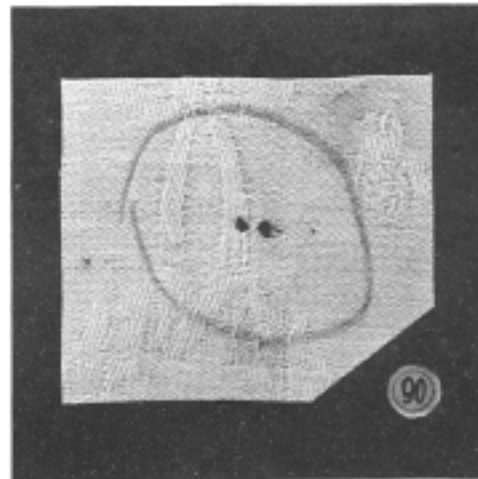
Fig. 12

Metallic objects no larger in size than a pin head, often are found in gray goods, as illustrated by Figure No. 12. Experts consulted in the matter invariably agreed that they get into the cloth during loom fixing. They are particularly treacherous because they escape detection on account of their small size. They seldom cause rust stains in bleaching, but are just big enough to play havoc in calendering.

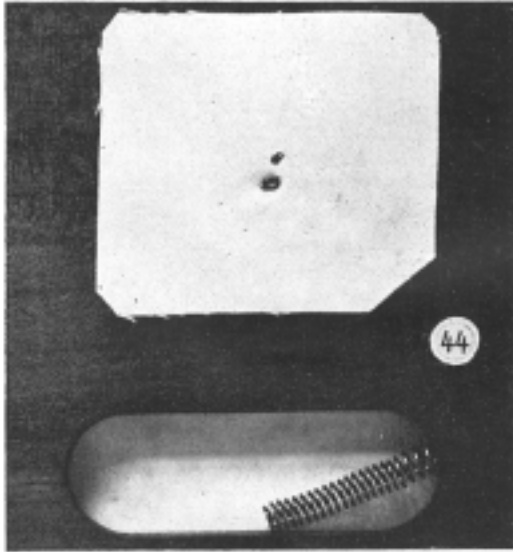
Fig. 13

Figure No. 13 shows a brass spring in a fabric made on a Jacquard loom. The round object, seen on the fabric, is part of a spring which had broken off and was imbedded in the cloth. It was not discovered until sev-

eral pieces of the cloth had been damaged in calendering.

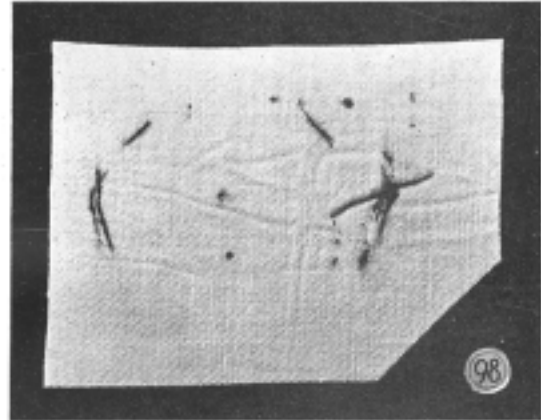
Fig. 16

Figure No. 15 shows a piece of wood thoroughly woven into the cloth. Figure No. 16 shows a piece of wire in the cloth which caused rust spots in the fabric during bleaching. Figures No. 17 and No. 18 show fragments of wire, and No. 19 a weaving defect in conjunction with an oily piece of

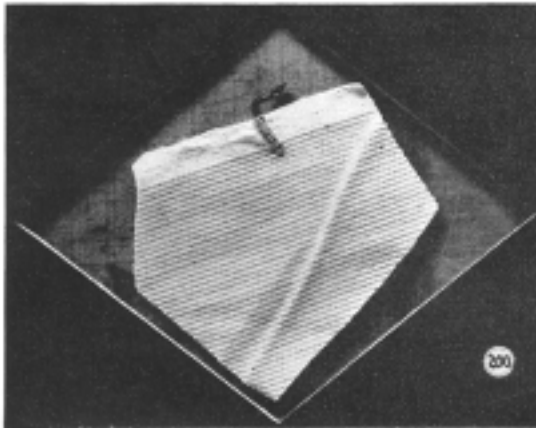
Fig. 14

In Figure No. 14, a piece of a broken nail from a reed cover was woven into the selvage. The nail fell at the moment when the shed opened and was woven into the very edge of the selvage.

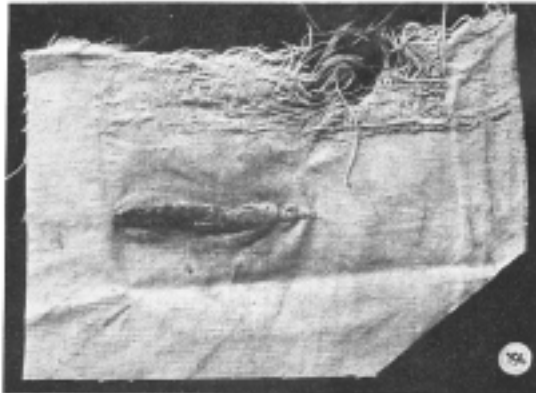
Fig. 19

waste. Closer inspection revealed a steel pin of unknown origin inside same. Many more pictures could be added to this chapter of woven-in objects, but it is considered sufficient examples have been illustrated.

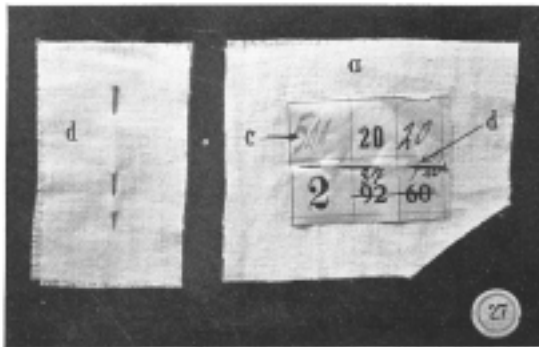
Fig. 21

In Figure No. 21, a pin was used to fasten a ticket. Mark (c) was made with a pencil. In the transfer of the goods from the weave room to the bleachery, the slip tore off, but the pin (d) remained in the cloth. A pin may easily be overlooked by a workman in a finishing plant, but does become a source of serious trouble.

It is plainly seen that these methods of marking will cause a great deal of harm in finishing. The marking can be done effectively in a more harmless way.

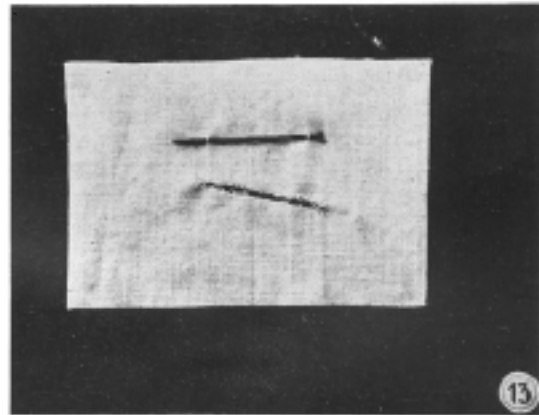
Fig. 22

Figure No. 22 shows a cloth cut by two rolls. No. 23 shows a defect in the cloth which the examiner had marked with a pin left in the cloth, instead of indicating the defect with a plainly visible tie thread at the selvage.

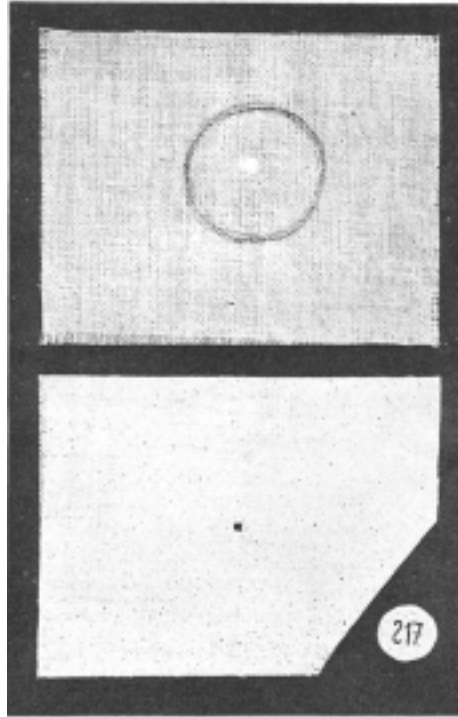
Fig. 24 a and b

Another reason is that a great many times one loom only causes the mischief. One treatment, eventually develop holes. This is illustrated by Figure No. 24 (b).

particular case with dull looking places in the gray goods was caused by the sand roll of a loom. When the sand roll is very sharp, it is covered with a light piece of cloth to prevent injury to the fabric being woven. In the course of time, the covering wears out, and when the bare perforated tin of the sand roll presses against a hard cloth roll, it leaves impressions in the cloth and these are repeated with every revolution. Such impressions do not leave any visible holes at first, as Figure No. 24 (a) indicates. However, in the course of the finishing, beginning with the singeing and the subsequent processes, broken yarn appear which in the course of further
